# Cantor Property Inspection

## CONFIDENTIAL INSPECTION REPORT

**INSPECTION ADDRESS**  
12345 Main Street, San Diego, CA 92128

**INSPECTION DATE**  
7/28/2010 1:30 pm to 5:30 pm

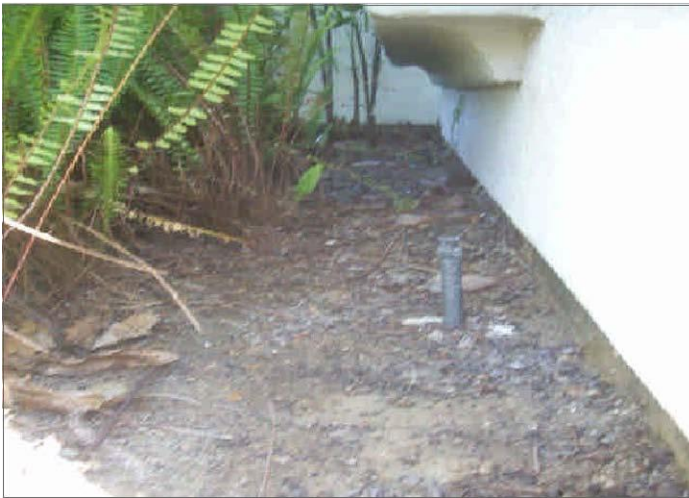
2.8 - There is an area at the front of the home, where water will be directed toward the foundation instead of away from it, as recommended. This not only allows for the possibility of moisture intrusion, but also differential settling, et cetera. Further evaluation by a licensed foundation/drainage contractor is advised.

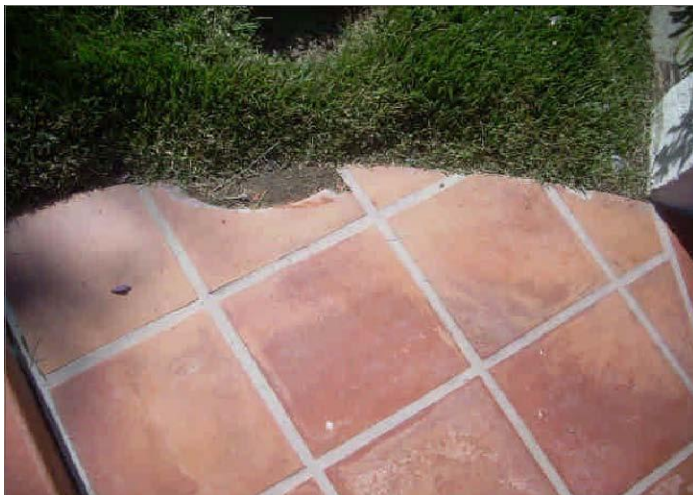
2.17 - The walkways have common cracks and damage noted throughout, which are not in need of repair, but may pose as a trip hazard.

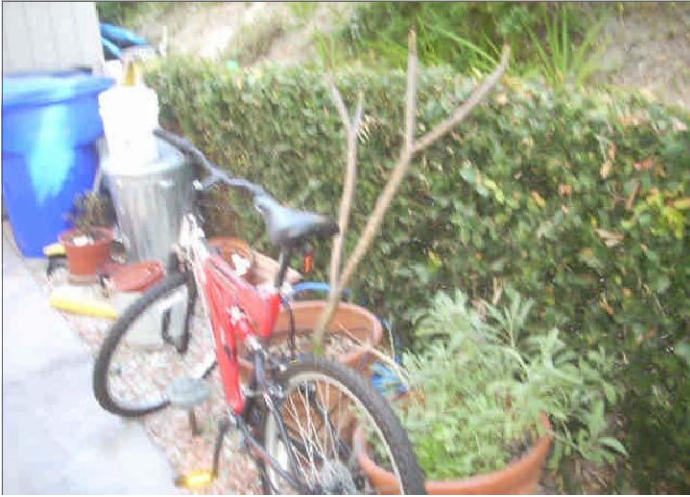
2.18 - The yard walls may have some cosmetic damage, but are functional.

2.19 - Some portions of the yard walls are obscured by foliage or other material and could not be fully examined.

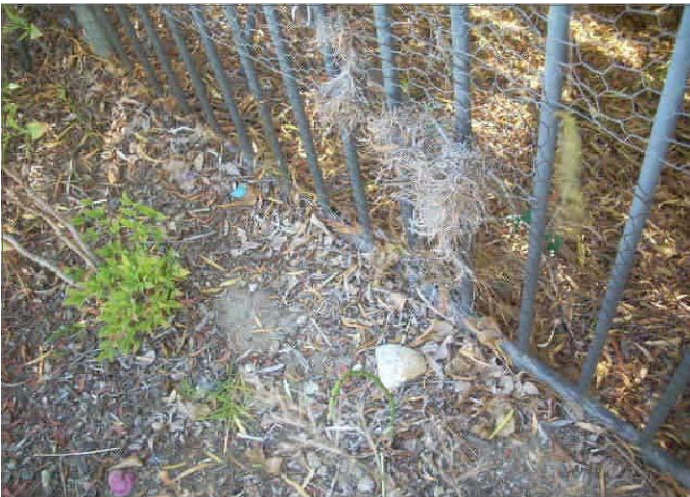
2.22 - Sections of the wrought iron fence have typical rust damage and should be serviced or monitored.

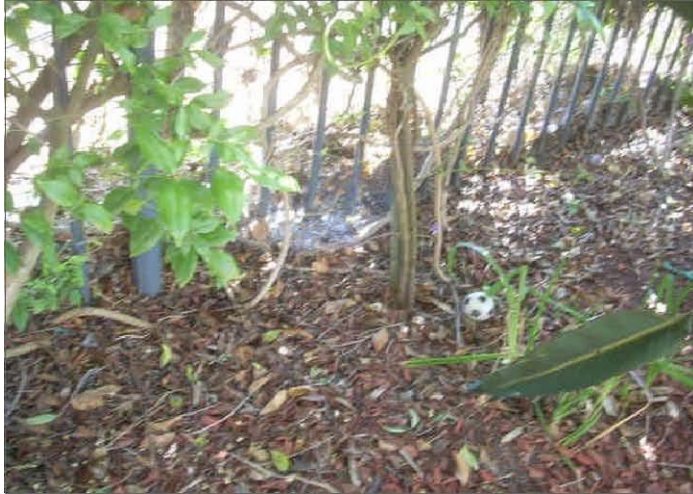
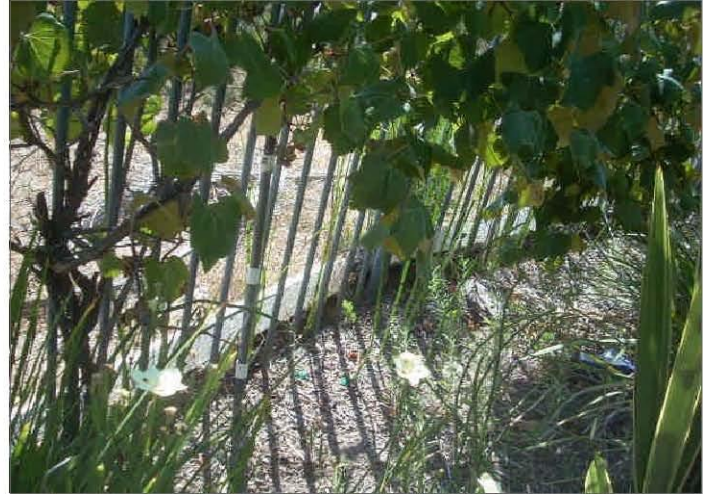
2.23 - Removing the soil from the bottom rails of the wrought iron fences will extend their life.

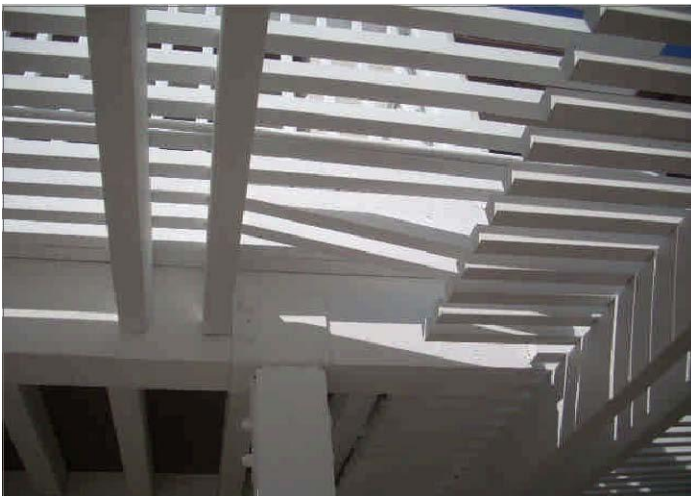
2.28 - The rear aluminum patio covers are functional, however, there a couple of damaged 1x1 on the top of the cover over the barbeque.

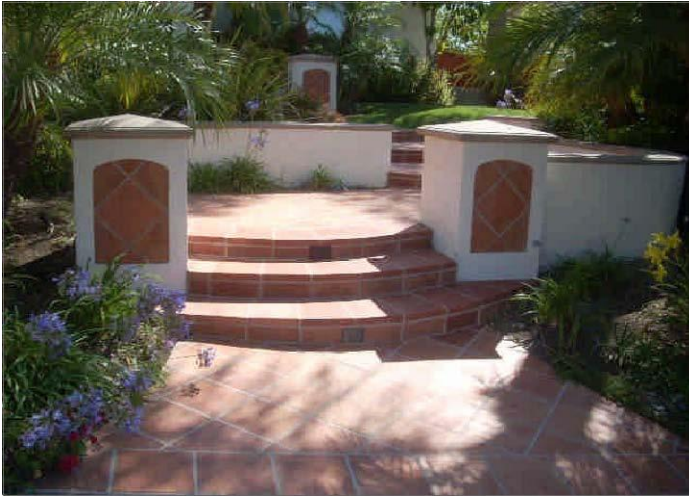
2.32 - As a safety precaution, we recommend installing handrails on steps that have three or more risers, and particularly if children or the elderly visit or occupy the property.

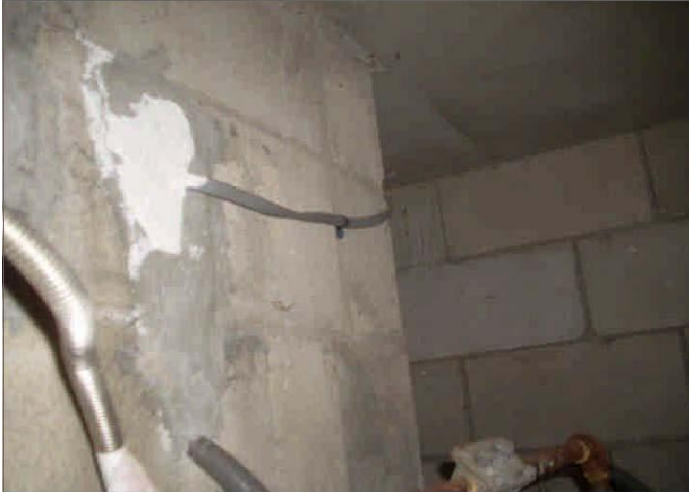
2.39 - The barbeque area was not inspected and is not part of this report. However, the following was noted: There is no outlet for the refrigerator to plug into. An extension cord wire is currently run over to, and is improperly attached to the backside of an outlet. Further evaluation and repair by a licensed electrician is advised.

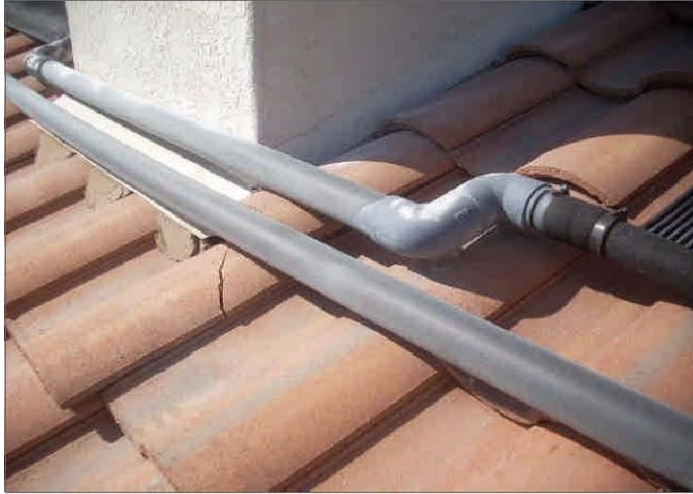
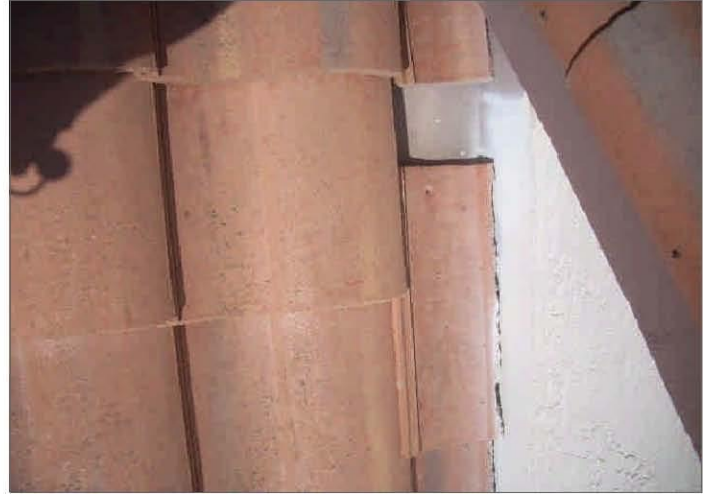
3.6 - There is one cracked tile at the rear of the roof, near the chimney, and one displaced tile, at the roof to wall on the West side of the roof. Further evaluation and repair by a licensed roofer is advised.

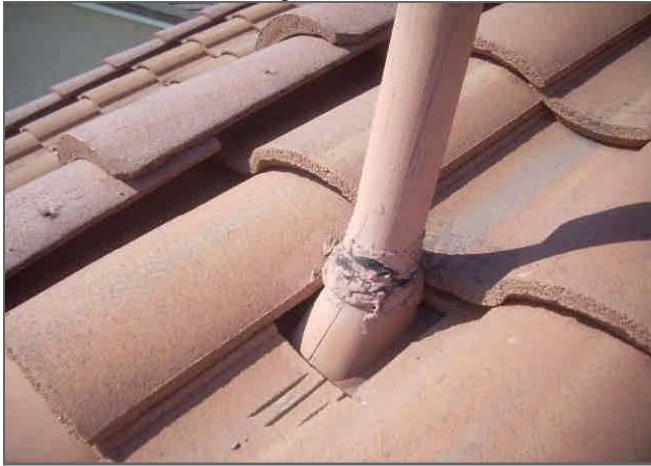
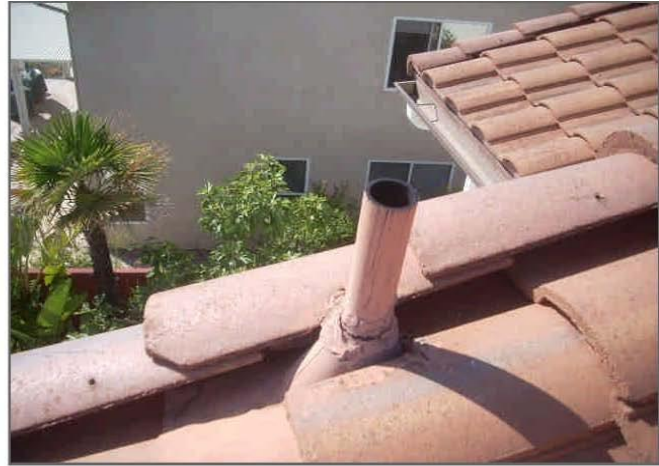
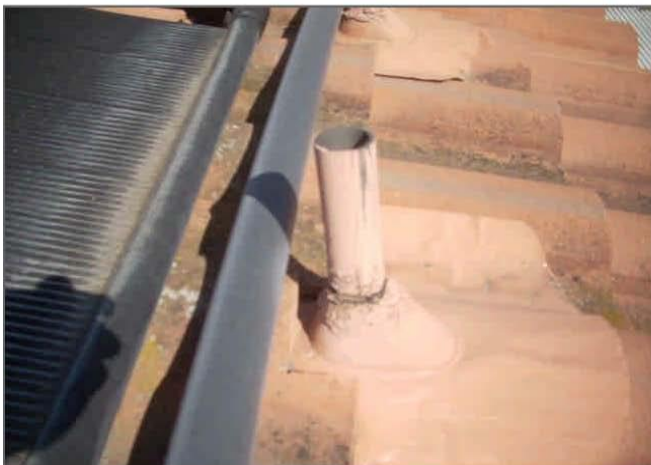
Some of the roof flashings need to be sealed or serviced – *Continued*

3.8 - Some of the roof flashings need to be sealed or serviced. They are comprised of metal that seals valleys and vents and other roof penetrations, and are the most common point of leaks. This is particularly true of the flashings on a layered roof, which are covered by the roofing material and which are even more susceptible to leaks.

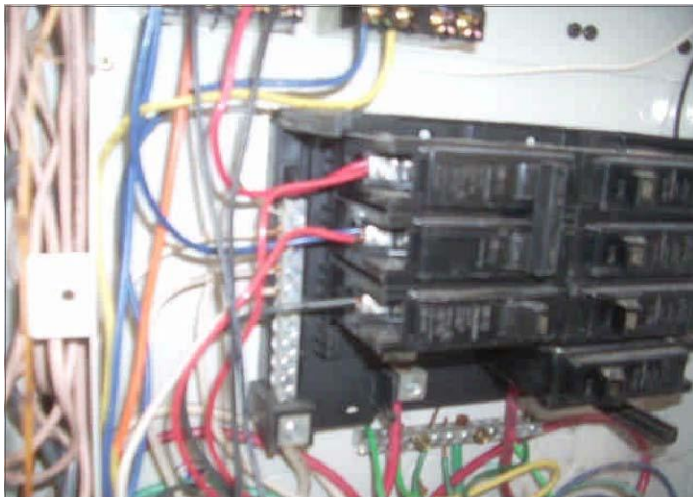
5.18 - Two twenty-amp circuit breakers are serving two circuits in the sub panel, which could overload the circuits. Further evaluation and repair by a licensed electrician is advised.

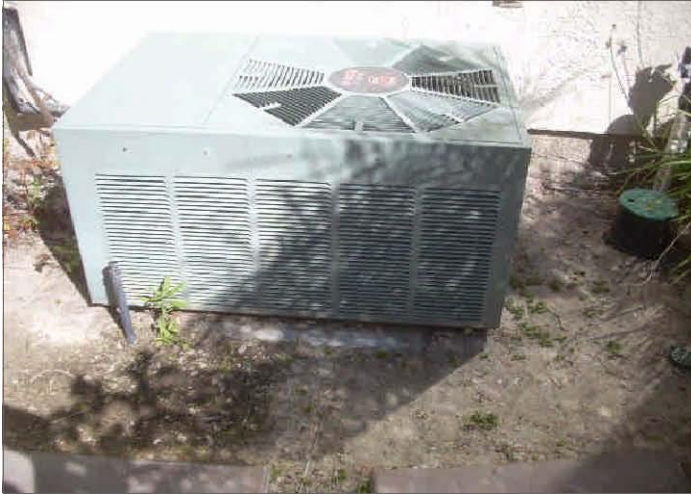
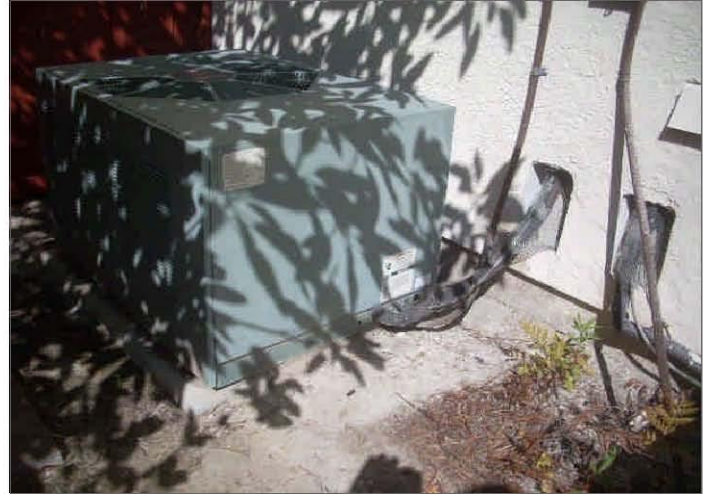
6.14 - The condensing coils are raised to prevent moisture contamination, but not the recommended height of three inches above the surrounding grade. Lowering the grades around the condensing coils is advised.

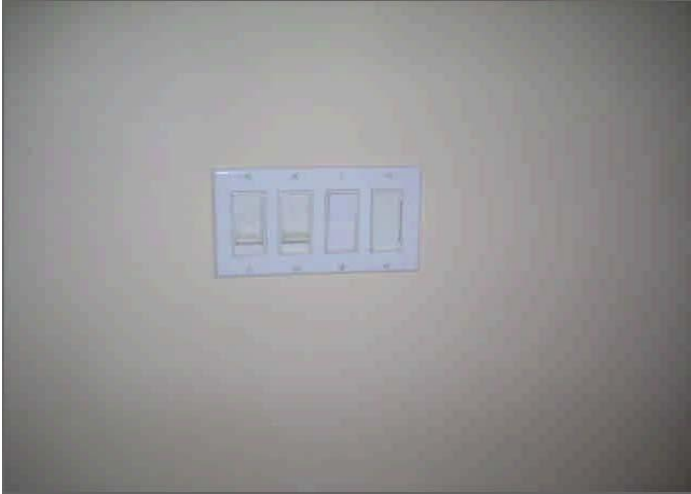
The dimmer switch that operates the can lights in the living room is damaged - *Continued*

8.8 - The dimmer switch that operates the can lights in the living room is damaged. Further evaluation and repair by a licensed electrician is advised.

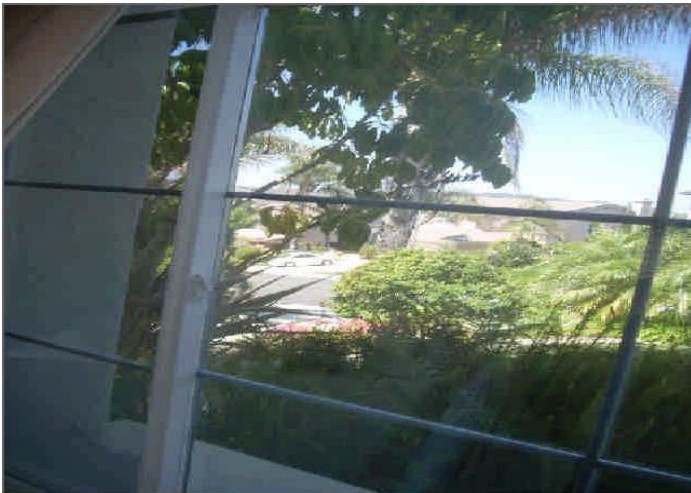
The windows are functional - *Continued*

8.13 - The windows are functional, however, one of the operable windows does not close and latch properly, and should be serviced.

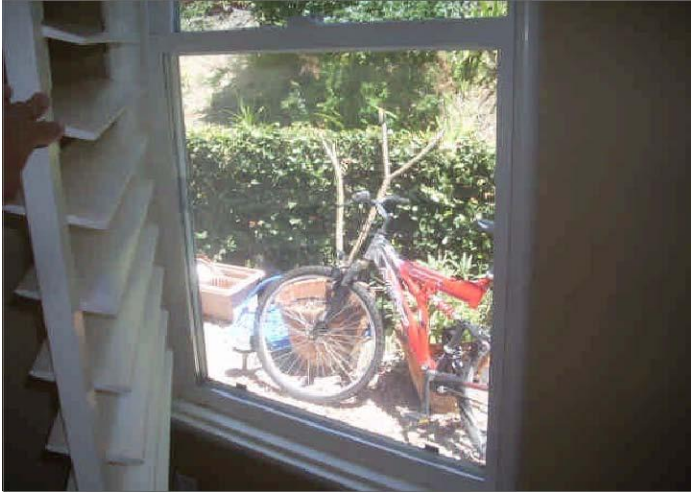
8.26 - Tinting has been added to the some or all of the windows. The tinting is damaged on one of the windows. Adding tinting to window will sometimes void a manufactures warranty.

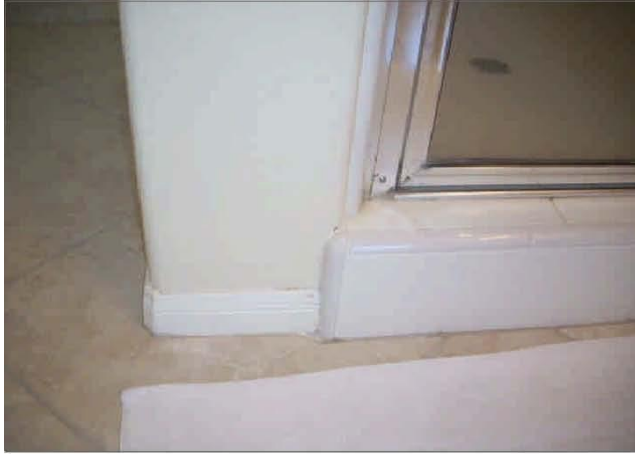
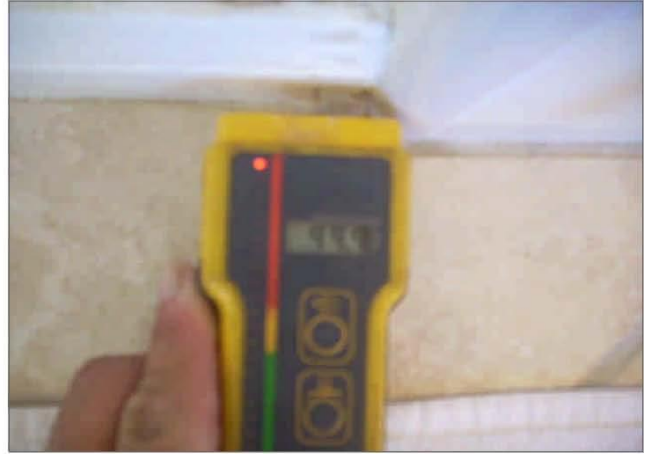
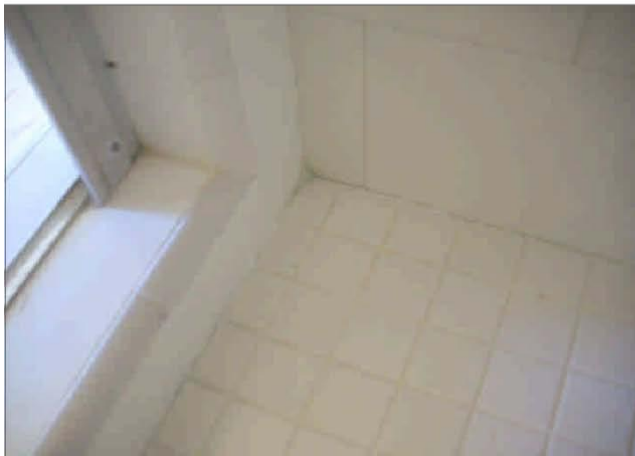
10.14 - Moisture was detected behind the tiles at the exterior of the shower pan, and in the drywall and baseboard, next to the shower pan. A Protometer brand moisture meter was used to make this detection. Further evaluation and repair by a licensed contractor is advised.

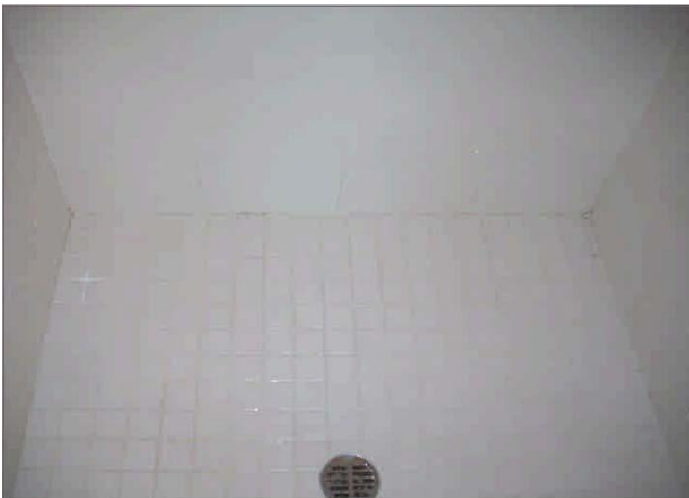
10.15 - There are open grout-joints in the stall shower tiles that should be sealed to prevent moisture damage.

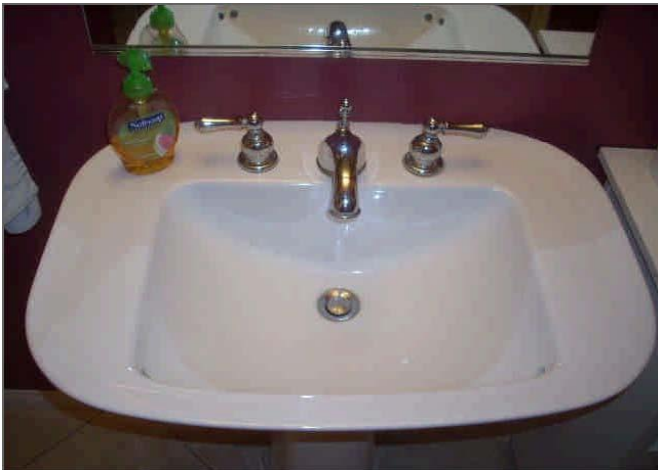
There is a water hammer in the wall when the hot side of the sink faucet is turned off - *Continued*

10.42 - There is a water hammer in the wall, when the hot side of the sink faucet is turned off. Further evaluation and repair by a licensed plumber is advised.

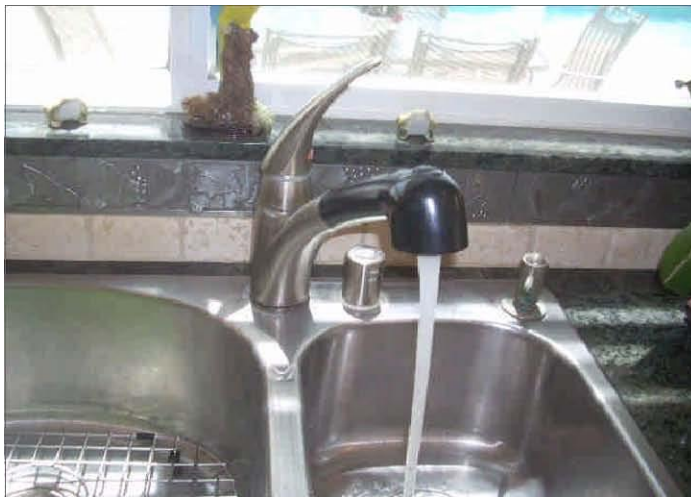
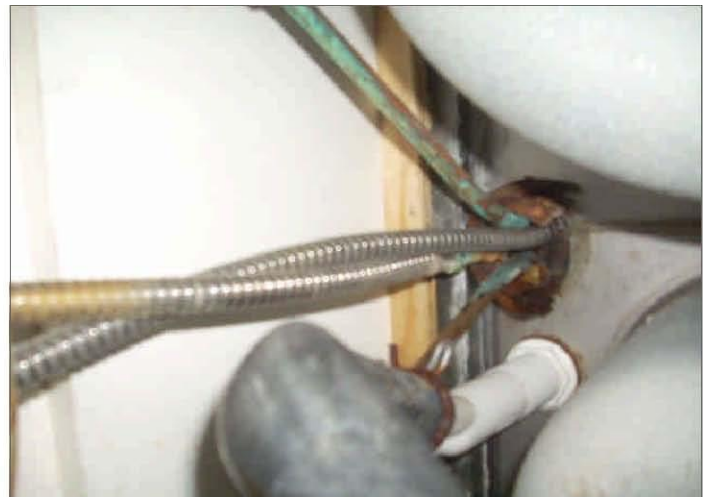
11.9 - The faucet leaks around the stem while in use, which is indicative of a defective seal, and should be repaired or replaced by a licensed plumber.

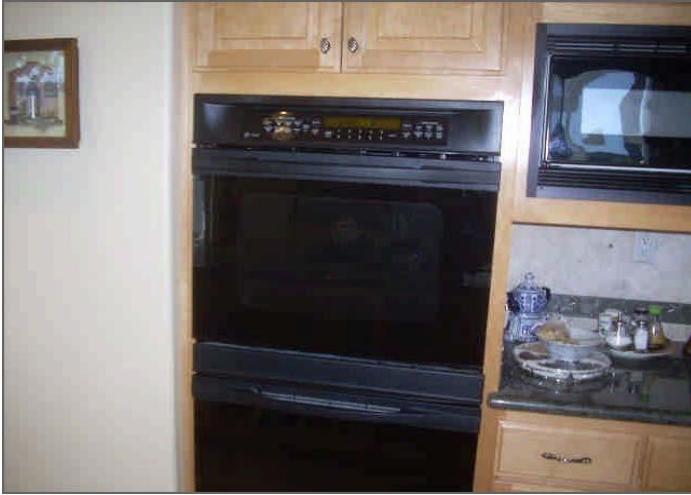
Both electric ovens were functional - *Continued*

11.14 - Both electric ovens were functional, however, the fan makes an unusual sound when the upper oven is in convection mode. Further evaluation and repair by a licensed appliance repair contractor is advised.

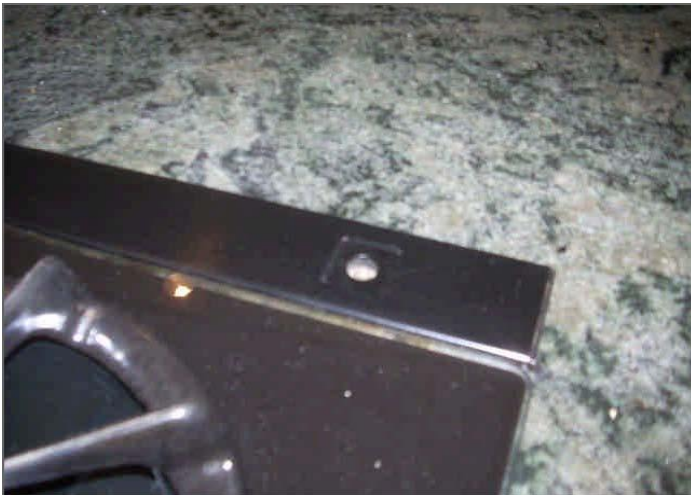
11.17 - Components of the downdraft are broken or missing, and should be repaired or replaced.

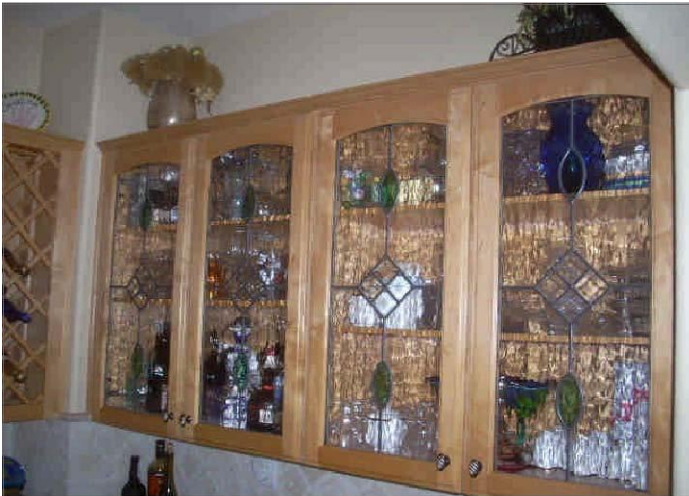
11.27 - The glass in the cabinet doors may not be tempered safety glass, as required by building standards.

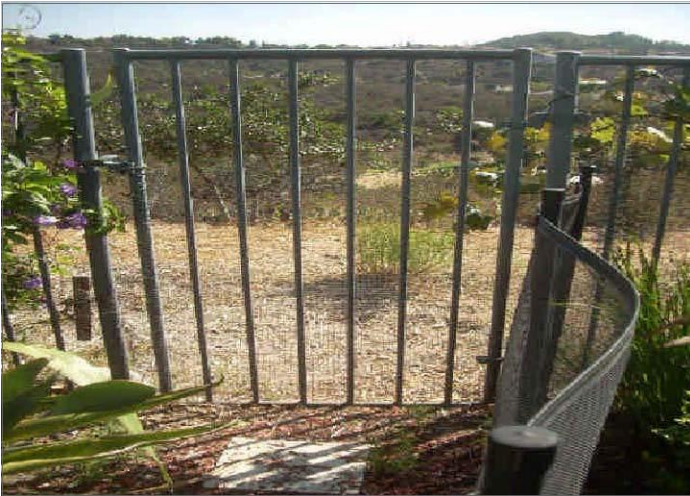
12.1 - The gates that give pool or spa access are not compliant with common safety standards, and should be serviced. Gates giving access are required to self-close and include latches at forty-eight inches and, ideally, should open away from a pool or spa, so that a toddler could not simply push open an unlatched gate.

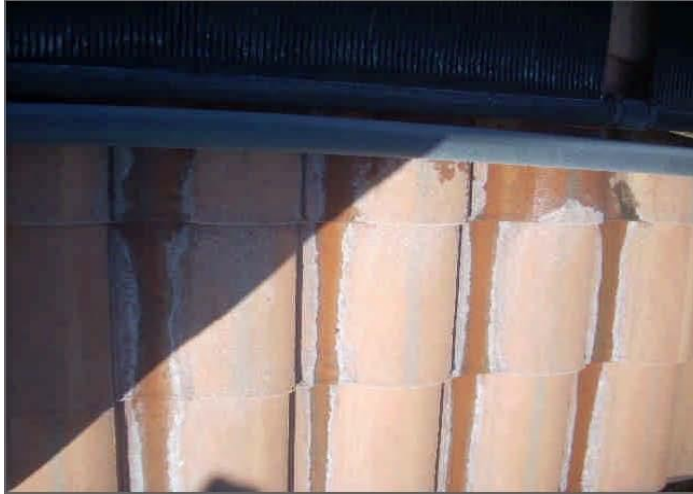
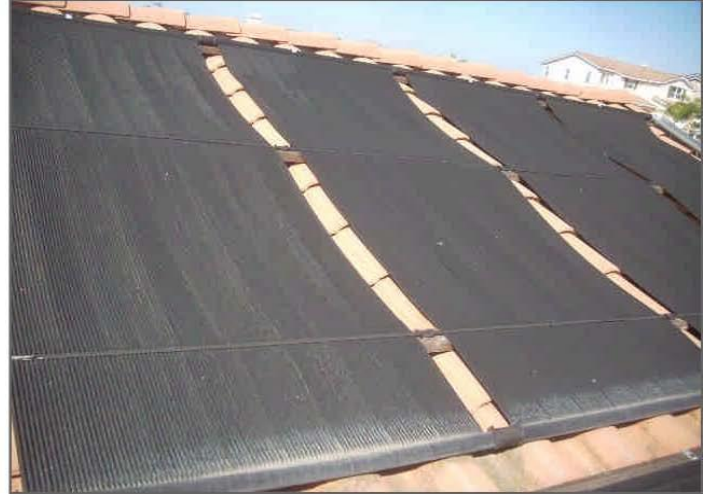
12.3 - Components of the solar system for the pool are in disrepair and should be serviced as follows: There is a leak at one of the solar panels on the roof. Further evaluation and repair by a licensed pool contractor is advised. Components of the solar system for the pool are in disrepair and should be serviced - *Continued*

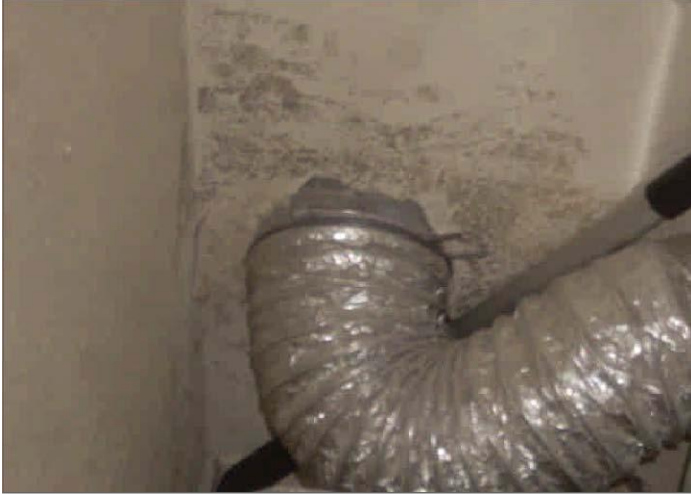
15.4 - There is a mold like growth on the wall around the dryer vent. Further evaluation by a licensed mold specialist is advised.

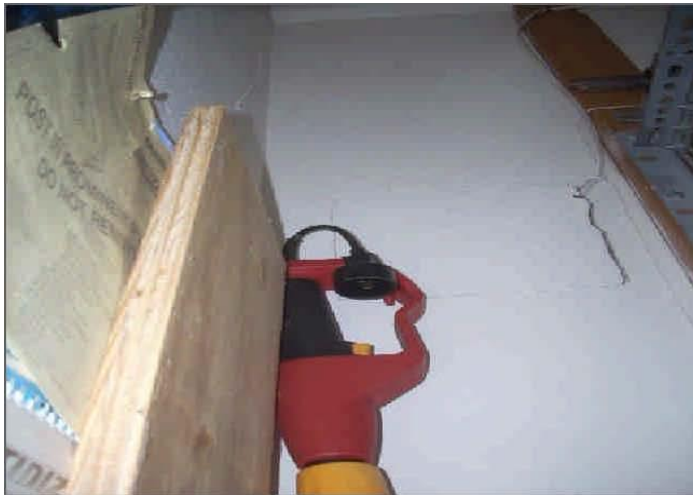
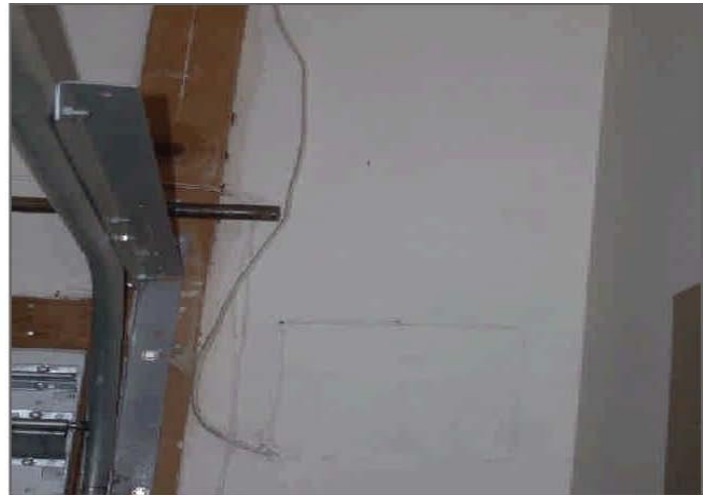
The voids in the garage firewall must be repaired - *Continued*

16.7 - The voids and or damage in the garage firewall must be repaired, in order to maintain the necessary firewall separation between the garage and the residence.

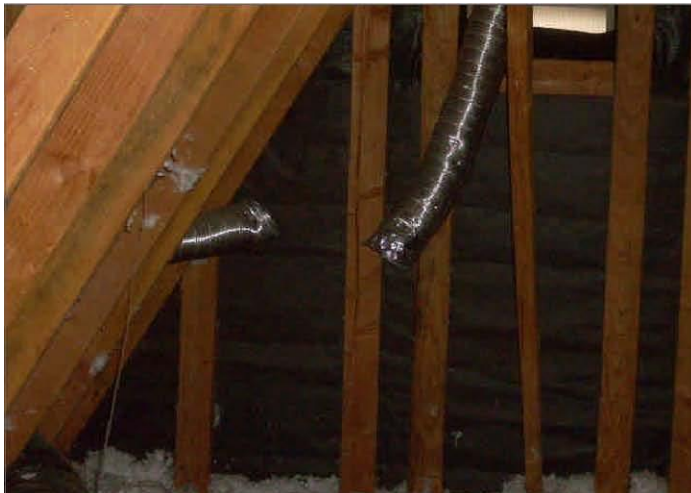
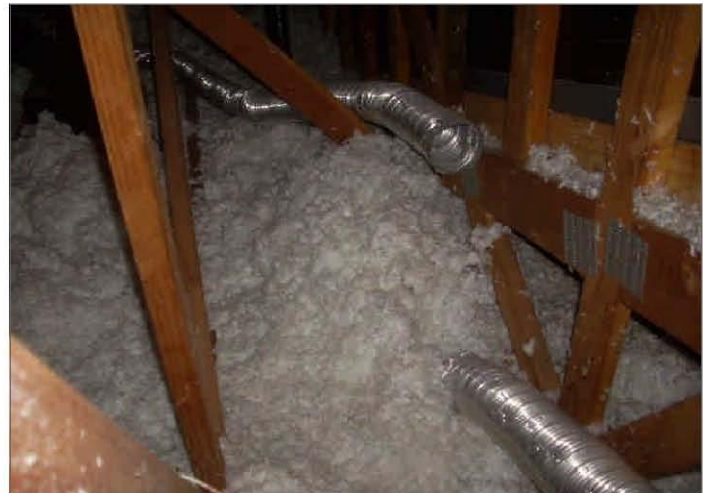
17.9 - The bathroom exhaust ducts are separated, and should be repaired.
